Technical Note N-1450

EXPERIMENTAL POLYURETHANE FOAM ROOFING SYSTEMS

John R. Keeton, Robert L. Alumbaugh, Ph D,
and Edwin F. Humm

August 1976

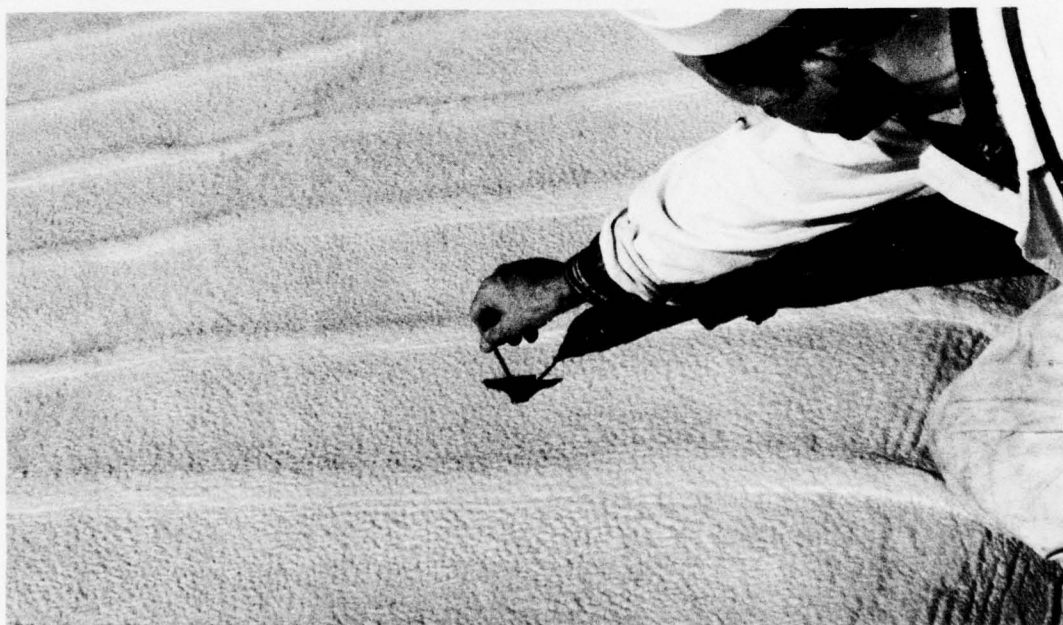
Figure 10. Measurement of Foam Thickness

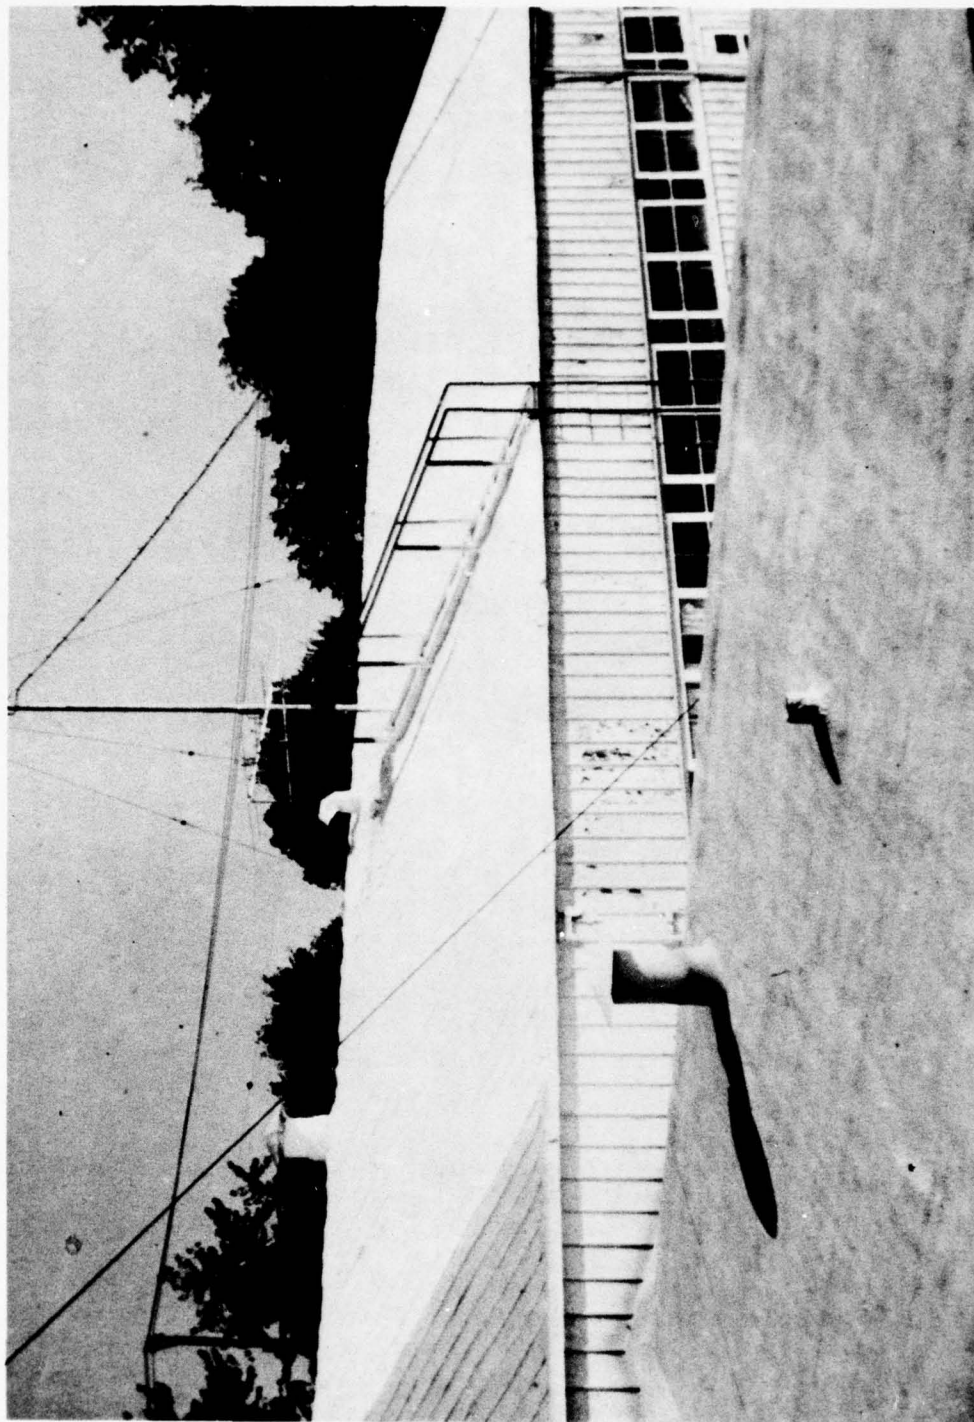
This one-part, moisture-curing silicone rubber coating was easily applied with conventional airless spray equipment. The light-gray base coat was permitted to dry overnight, and the white top coat was applied the following day. The completed south side of System 2 is pictured in the background of Figure 13.

Figure 13. Completed South Side of Moisture-Curing Silicone Rubber Coating Section (System 2)

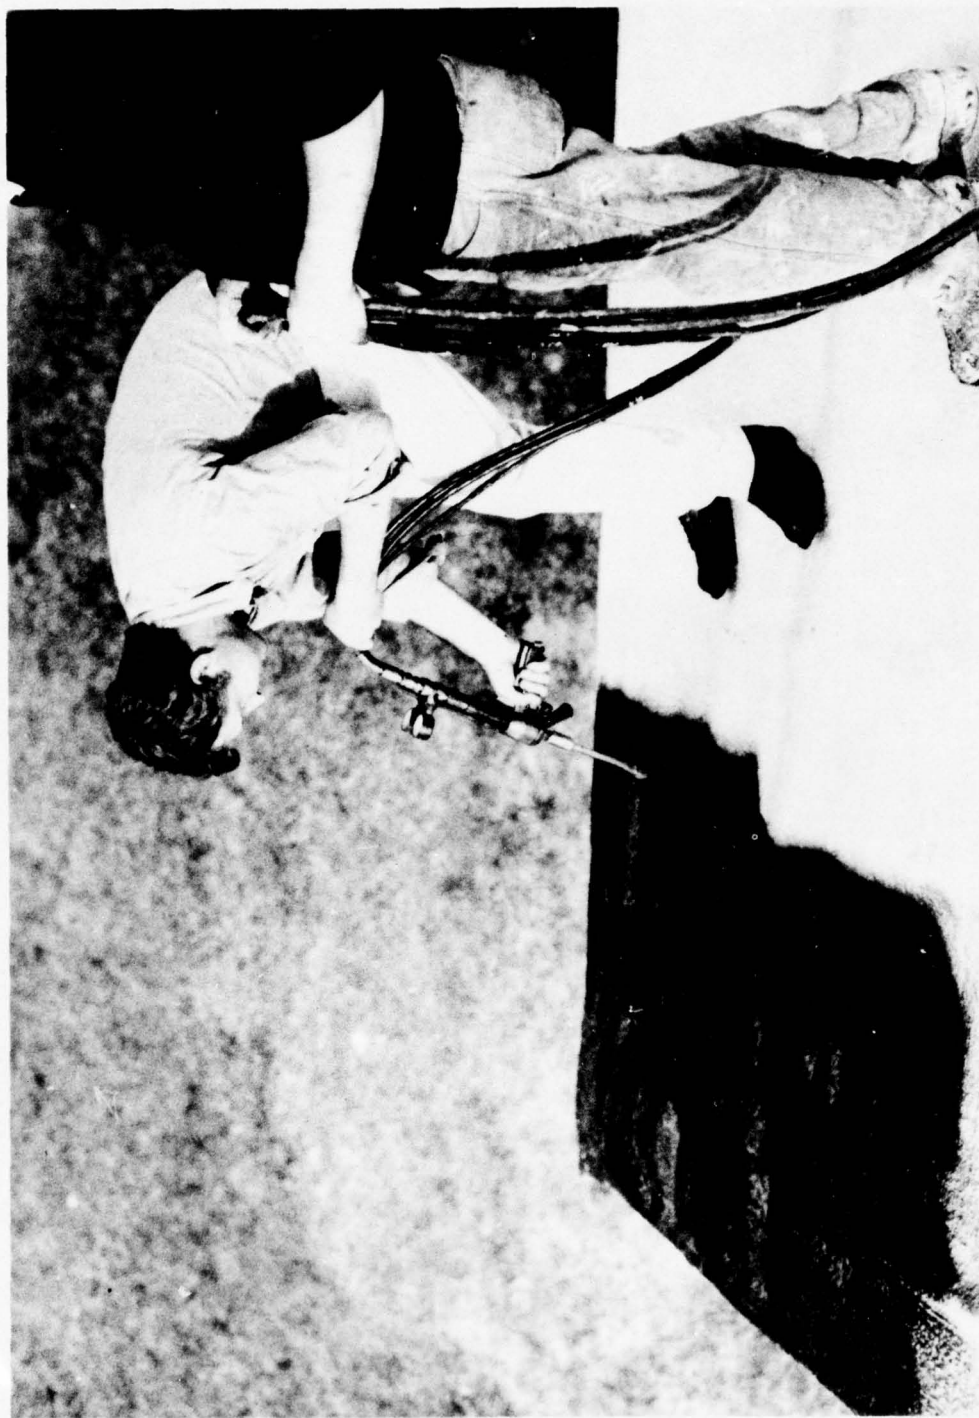
The coating materials of System 3 consist of one coat of a black, catalyzed butyl rubber base coat and one coat of a white, catalyzed hypalon top coat. The catalyzed butyl base coat has a relatively short pot-life and requires a special spray gun and apparatus for application. The two components of the butyl are thoroughly mixed as they pass through the mixing tube of the spray gun. Figure 14 shows the special spray gun being used to apply the black butyl base coat.

A great deal of trouble was encountered during application of the base coat. The spray gun became plugged a number of times, and each time it was necessary to disassemble and clean it thoroughly. In addition, the black butyl base coat was so thin that it tended to run when applied at the recommended rate. This was a greater problem on the north side than on the south side of this section. Accordingly, the north side was given a second coat of butyl the following day.

Figure 14. Spraying Black Butyl Base Coat of Catalyzed Butyl-Hypalon Coating (System 3)
With Special Spray Gun

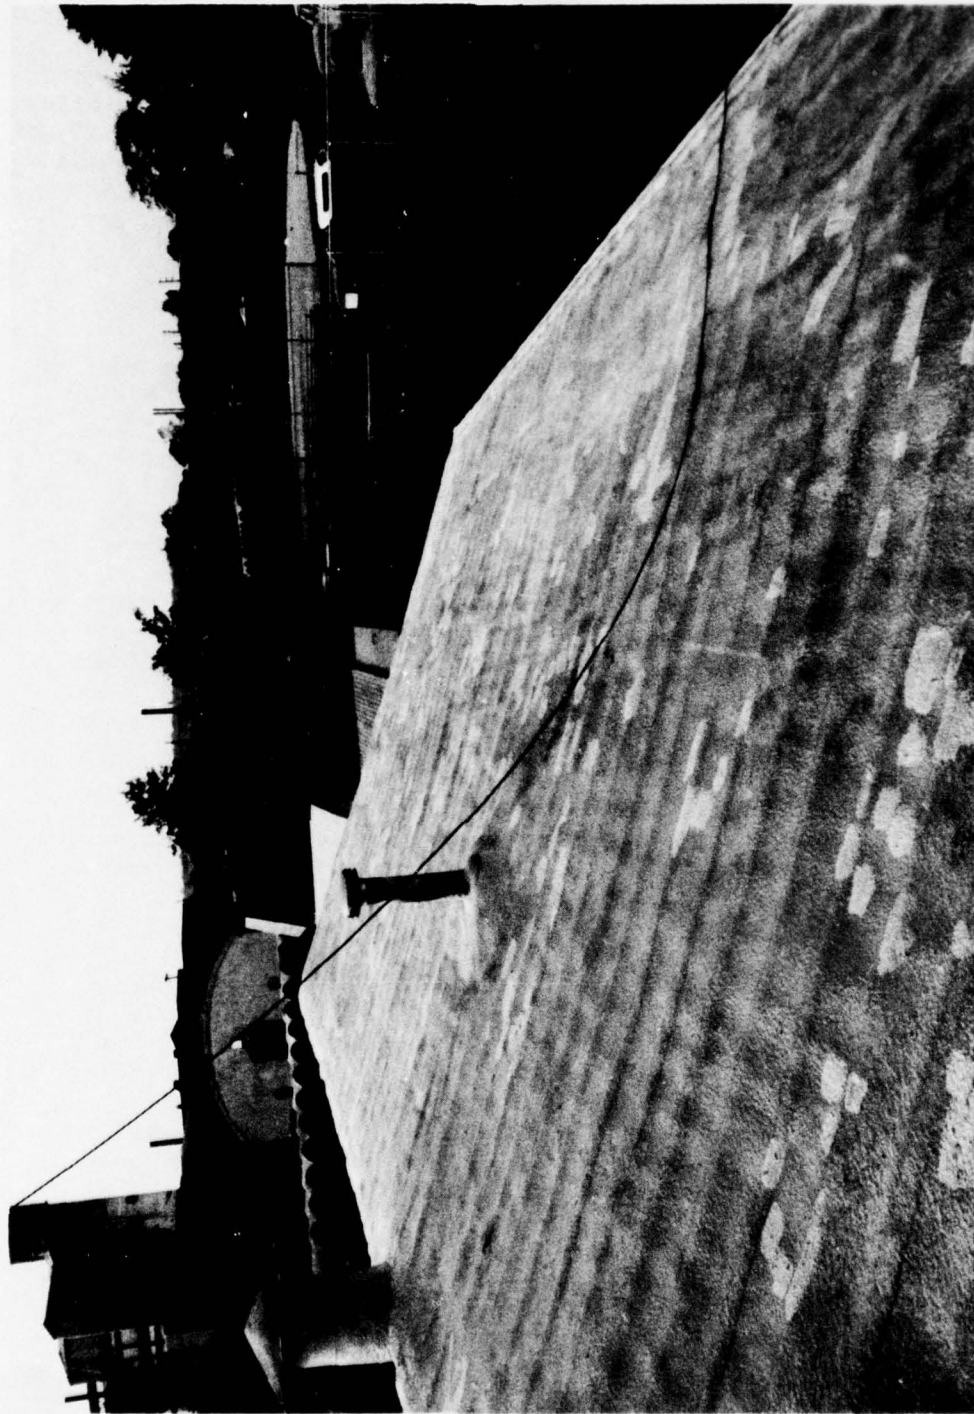
The white hypalon top coat was applied between 4 hours and 20 hours after application of the base coat. The hypalon was also very thin and had very poor hiding characteristics when applied at the recommended rate. Therefore, this system had a very blotchy appearance when completed. Both the base and top coats of System 3 were applied under the direction of the manufacturer's representative. The north side of the completed System 3 section is pictured in Figure 15. The light-colored spots are places where the manufacturer's representative attempted to overcome the splotchiness by spot-touching with the hypalon top coat the day following completion of the system.

Figure 15. Completed North Side of Catalyzed Butyl-Hypalon Coating Section (System 3)

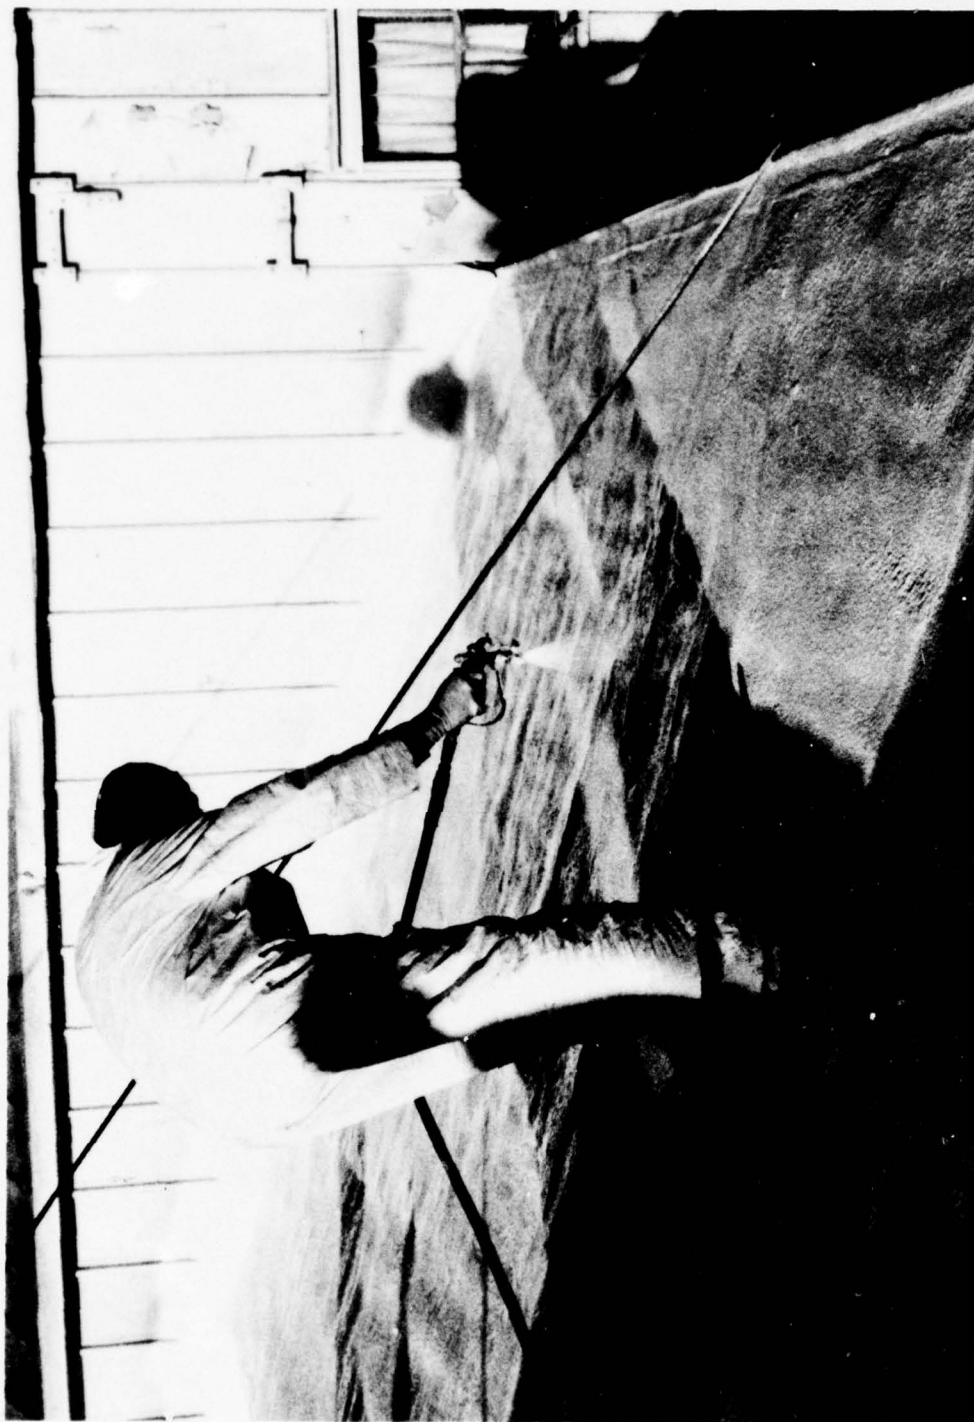
System 4. Hypalon Mastic. This coating system consists of one coat of a white, single-component hypalon mastic applied with conventional 40:1 ratio airless spray equipment. Although only about 30% solids, the mastic was very thixotropic, making spraying somewhat difficult. Heating the mastic with an in-line heater at about 125°F reduced the viscosity of the material sufficiently to enable it to be sprayed, but it was still necessary to purge the spray gun frequently to remove blockage and maintain a proper spray pattern. Figure 16 shows the hypalon mastic being applied to the foamed roof on the Boiler House.

Figure 16. Spraying Hypalon Mastic Coating (System 4)

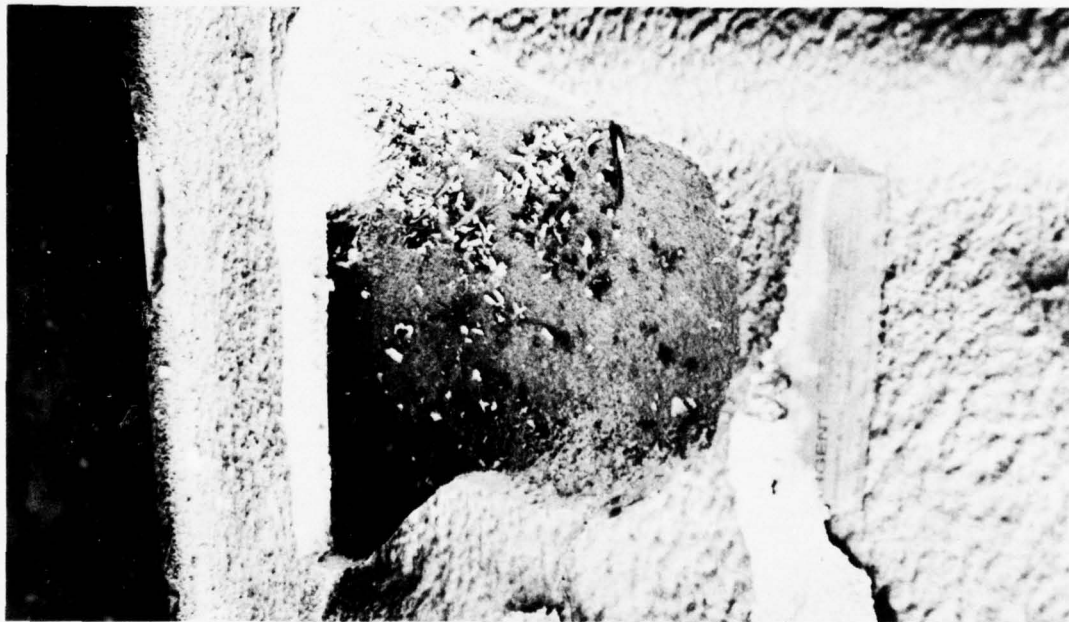
Figure 30. Area in System 2 Section Where Birds Pecked Foam From Beneath Gravel Stop

The largest instance of bird-pecking occurred in the System 2 section in a most unusual manner. Rather than pecking through the coating to reach the foam, the birds attacked the foam from underneath the gravel stop. The larger of two of these pecked areas is shown in Figure 30. Their repair is described in the following section.

(b) Void Exposed When Coating Was Removed.

Finally, during August 1975, two bird-pecked areas were discovered in the System 2 section, one of which was shown previously in Figure 30. In order to prevent the exposed foam from deteriorating, on-the-spot repairs were made by CEL personnel. The pecked areas were cut out with a sharp knife to expose good foam. The foam was then protected

with a cold asphalt roof patching material (Figure 49). These repairs should provide sufficient protection to the foam. Since the hollowed-out areas are adjacent to the gravel stop, standing water will run underneath the gravel stop and off of the roof.

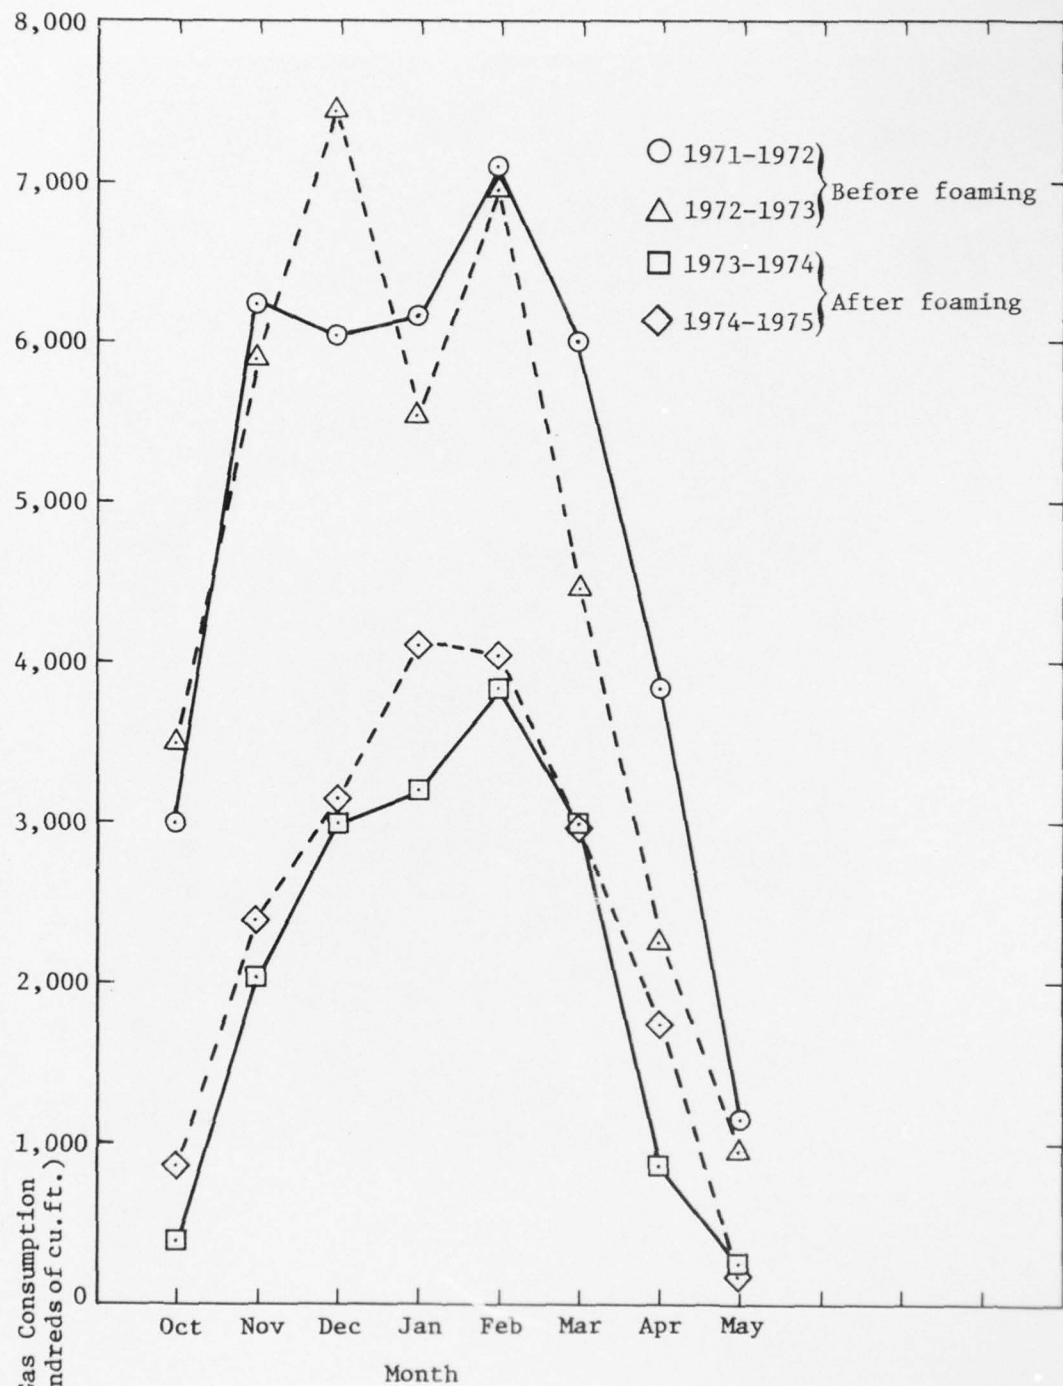
Figure 50. Heating Gas Consumption Before and After Foaming

Table 7 lists the natural gas consumption in cubic feet on a monthly basis. The second and third columns show the monthly gas usage prior to foam installation; the last two columns show gas usage since foam installation. On the next-to-last line is a summation of the gas consumption for the period of October through May for each year. There has been a rather dramatic reduction in gas usage since the roofs were foamed. In the last line of Table 7, the October through May totals are averaged for 2 years before and 2 years after foaming. This reduction in gas usage as indicated in the last line is 53%. Figure 50 also depicts rather impressively the decrease in consumption of heating gas since the roofs were foamed (October 1973).
